FINAL REPORT
January 2002

REPORT NO. 01-16

**M871A3 TACTICAL TRAILER
22.5-TON PAYLOAD CAPACITY
TP-94-01,
"TRANSPORTABILITY TESTING PROCEDURES"**

**REPORT NO. 01-16
M871A3 TACTICAL TRAILER
TP-94-01, "TRANSPORTABILITY TESTING PROCEDURES"**

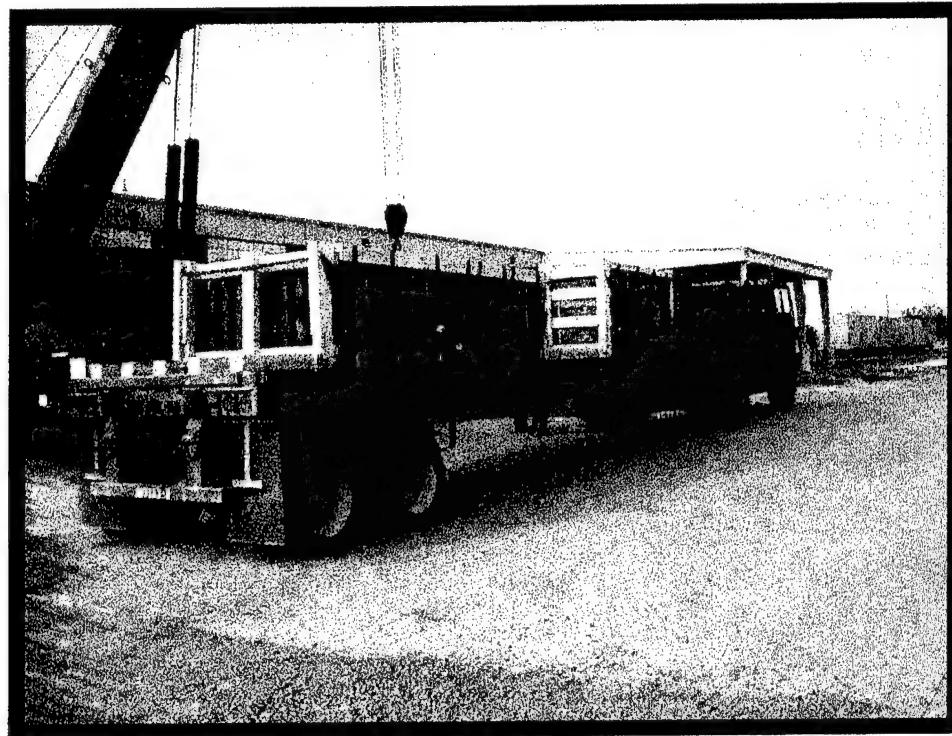
1. No damage or excessive movement occurred with the trailer or cargo tie-down rings during testing.
2. Following Pass No. 2, the strapping board broke and the end gate started to collapse. The load straps were tightened. This failure was not a result of the trailer design, and therefore, testing was continued.
